**ESTABLISHMENT OF MANUFACTURING METHOD AND TECHNOLOGY
FOR THE FABRICATION OF HELICOPTER MAIN ROTOR BLADE SPARS BY
CONTINUOUS SEAM DIFFUSION BONDING TITANIUM SHEET MATERIAL**

SIKORSKY AIRCRAFT

November 1978

Final Report - Contract Number DAAG-46-76-C-0016

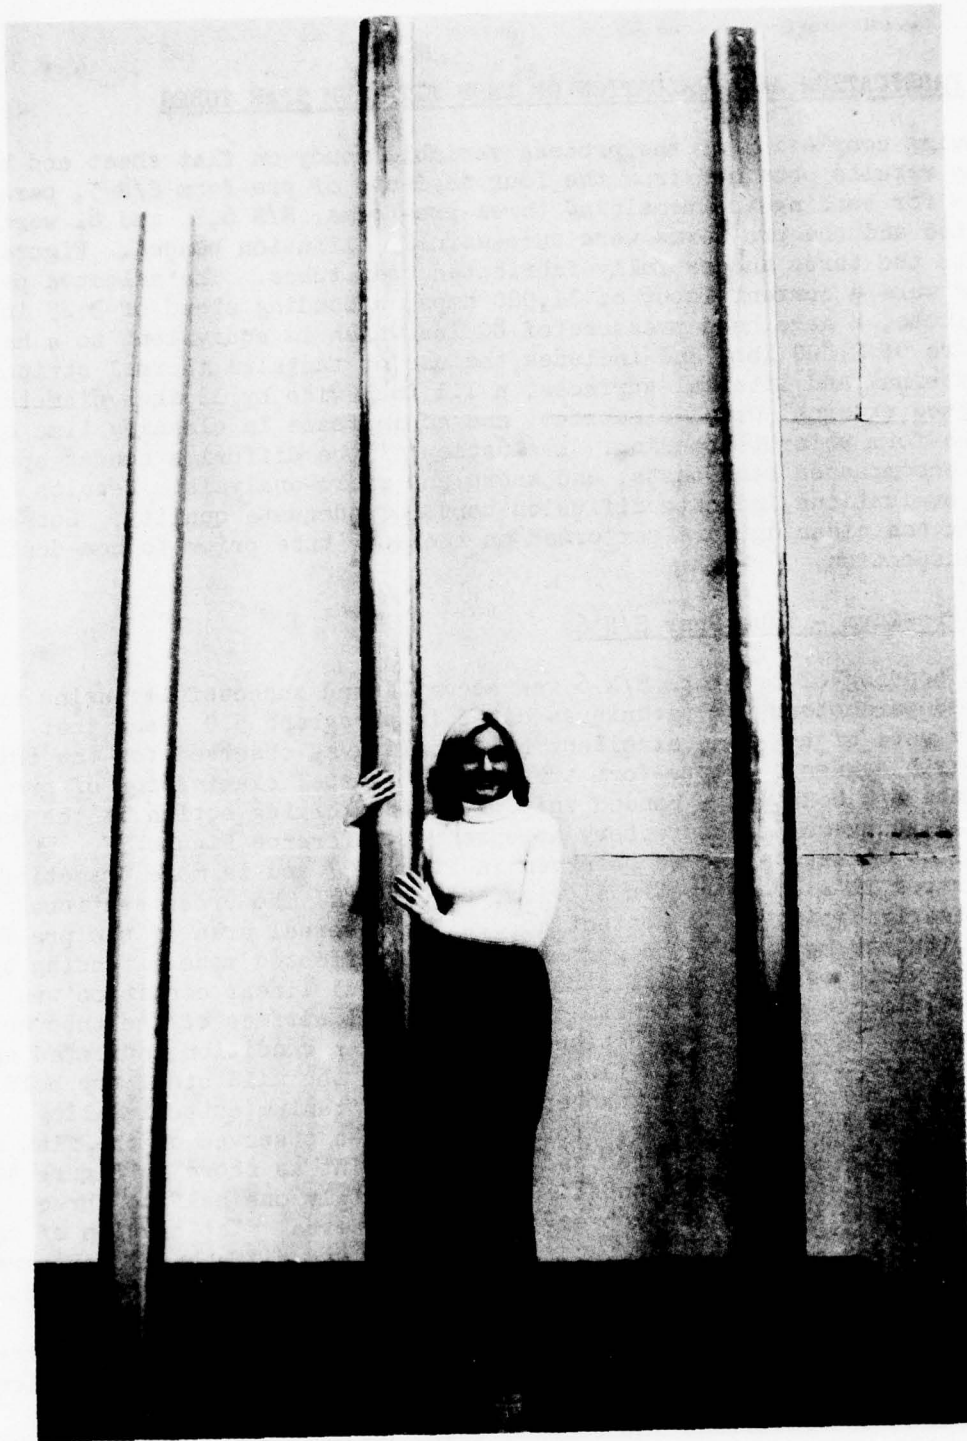
FIGURE 36. THREE, TEN FOOT SPAR TUBES SUCCESSFULLY FABRICATED.

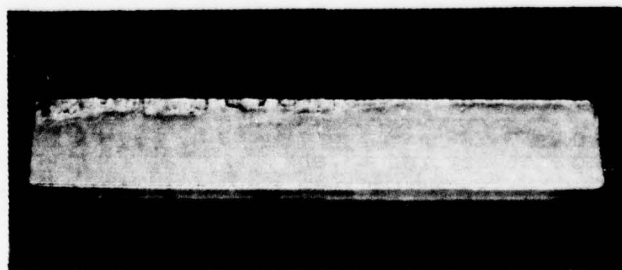
FIGURE 43. TYPICAL FLAT FRACTURE INTERFACE INDICATIVE OF POOR BOND. (NOT FROM PRE-FORM S/N 6).

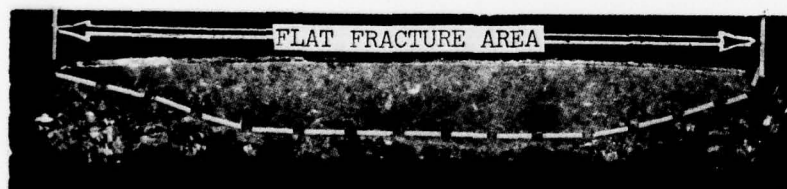
FIGURE 53. FRACTURE INTERFACE OF BEND TEST COUPON S/N 8-2.
(START END) NOTE FLAT FRACTURE AREA. MAG. 2X.

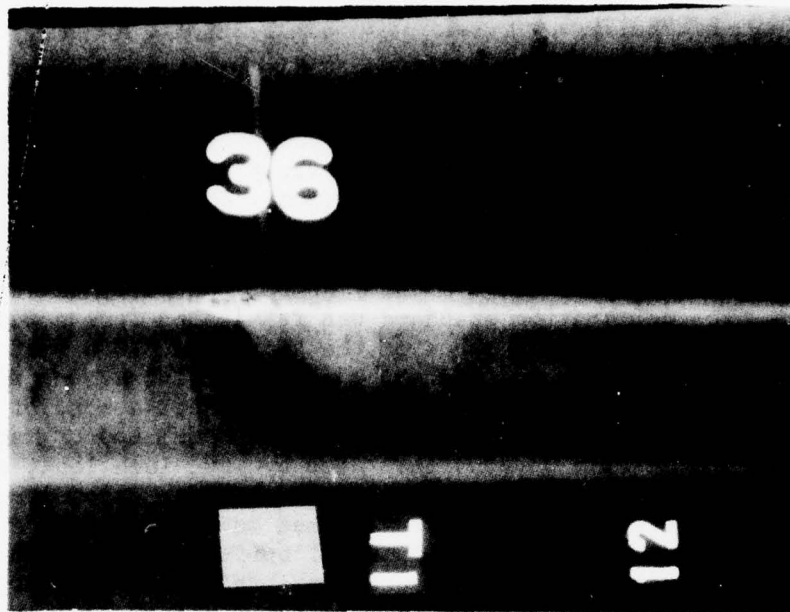
FIGURE 59. PHOTOGRAPH OF X-RAY DEPICTING INTERACTION CONDITION IN FLOWED METAL AREA ON INTERNAL SURFACE OF PRE-FORM S/N 7. MAG. 3X.

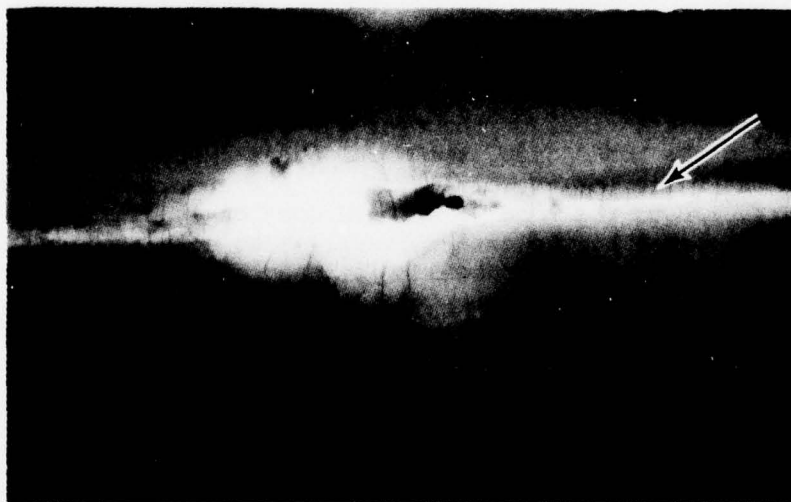
FIGURE 60. PHOTOGRAPH OF X-RAY OF INTERACTION CONDITION ON FLAT AREA ADJACENT TO METAL FLOW CONDITION ON EXTERNAL SURFACE OF PRE-FORM TUBE S/N 6, REFERENCE FIGURE 40. NOTE CRAZING CONDITION IN FLOWED METAL AREA. MAG. 3X.

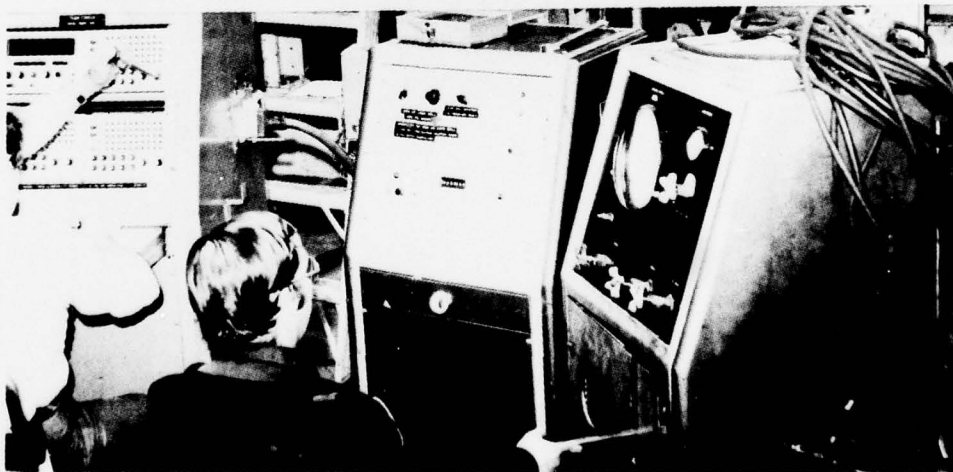
FIGURE 74. CALIBRATION SET-UP OF FULL-SCALE FATIGUE TEST SPECIMEN, S/N 7.

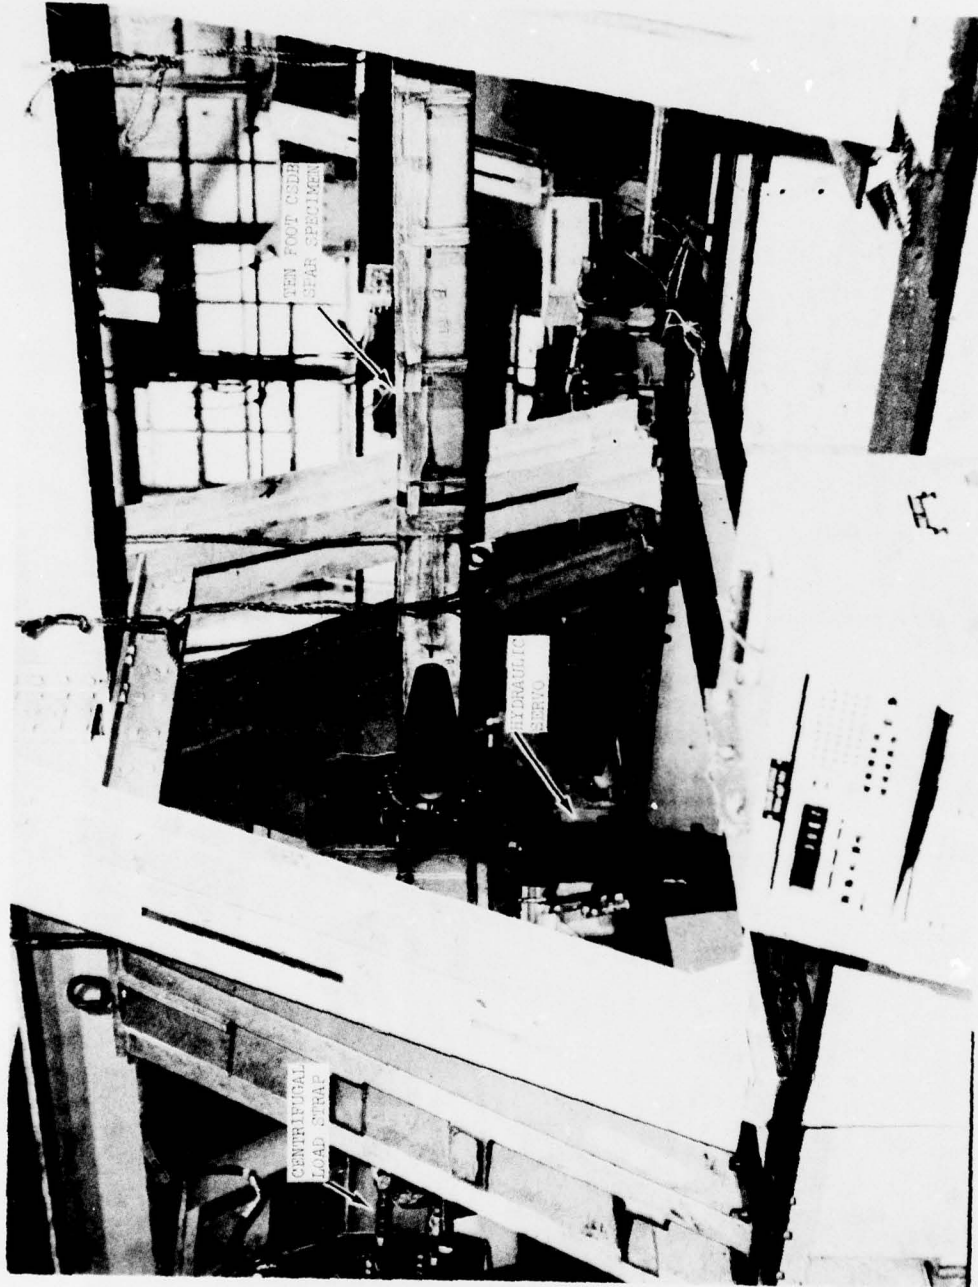
FIGURE 75. 200,000 POUND SEMI-RESONANT FATIGUE TEST FACILITY WITH TEN FOOT FULL SCALE BLACK HAWK SPAR S/N 7 INSTALLED.

After 145,000 cycles of testing at $+ 23,400 \pm 25,000$ psi, the specimen fractured thirty inches from one end (subsequently determined to be station 36). Prior to fracturing, the pressurized blade inspection system indicated a crack in the specimen. The crack was noted to be $3/4$ inches in length. While the test was being oriented to obtain crack propagation data, fracture of the specimen occurred with no significant additional cycles. A good bending moment distribution was attained during fatigue testing. The bending moment distribution curve

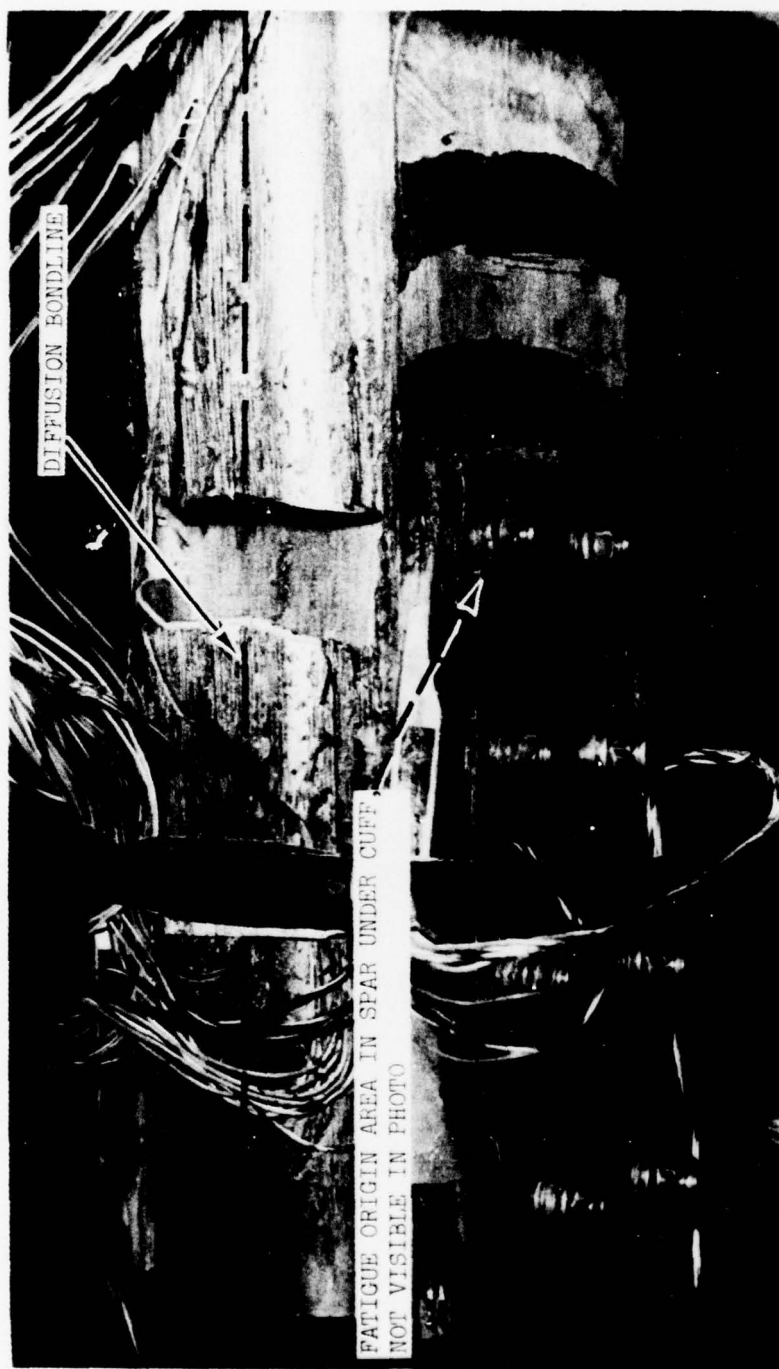
FIGURE 90. FRACTURE AREA, FATIGUE TEST SPECIMEN S/N 2-A.

Fracture of the short specimen D-spar was due to high inertial loads developed at the outboard cuff attachment end. The high inertial loads were directly related to the mass of the cuff attachments versus the mass (length) of the short specimen D-spar. Additional testing of a stiff shorter specimen, 7 feet, was not practical.

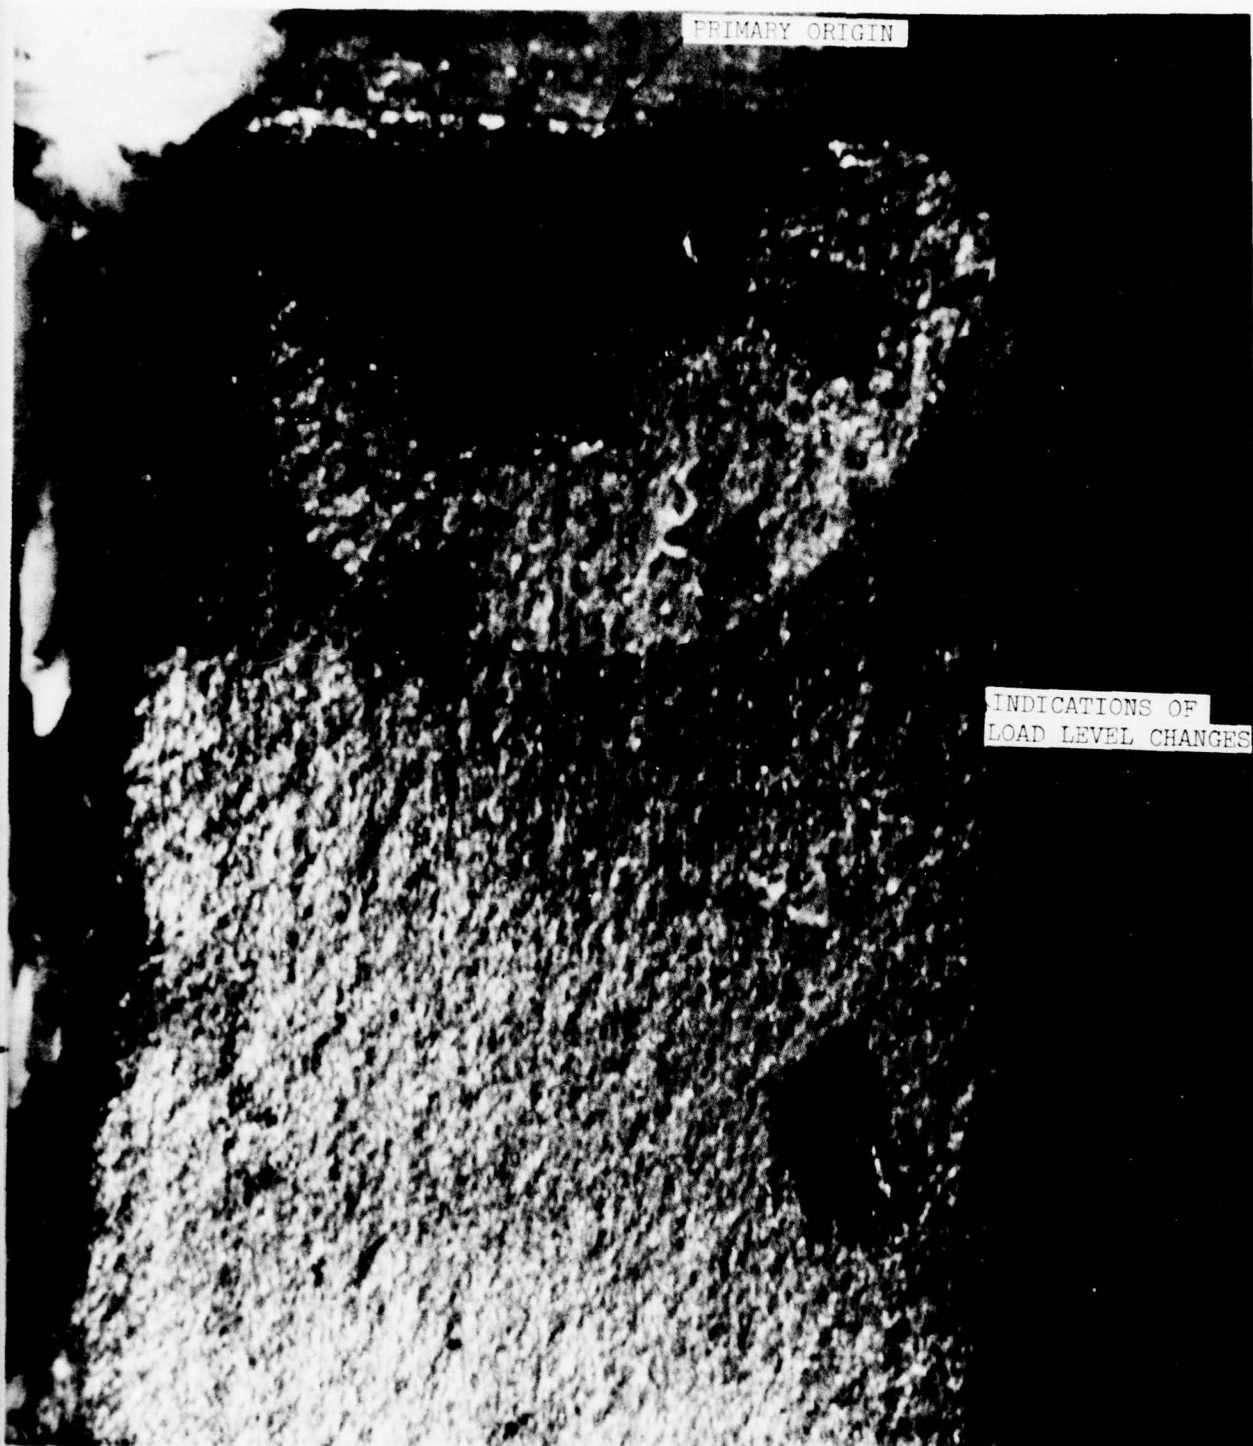
FIGURE 93. CLOSE-UP OF ORIGIN AREA.
(NOTE INDICATION OF LOAD LEVEL CHANGE, MAG. 40X)
